# Manhole Inspection Summary

Manhole # S29WW\_009MH

Insp Date: **5/16/07 11:31 AM**

**Location** Address: **728 SINGER AVE**

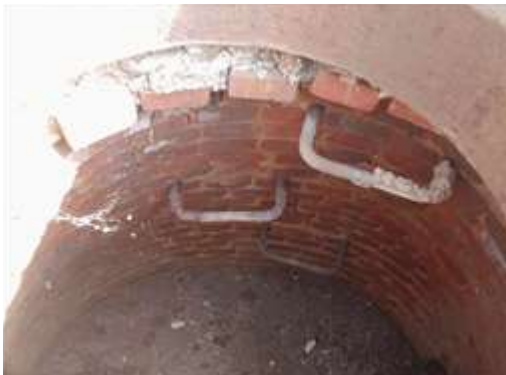
Defect

Channel debris

Adjustment deterioration, loose bricks and infiltration. Barrel infiltration.

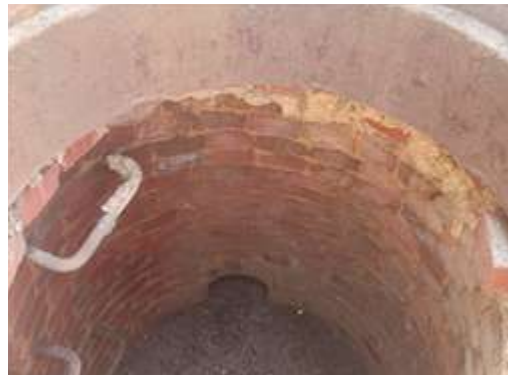
Defect

Adjustment deterioration infiltration. Barrel infiltration.

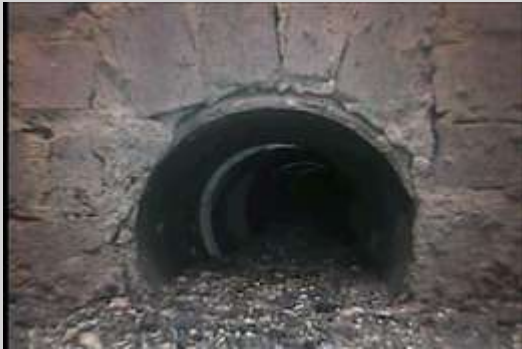
8 in. Circular Gravity Sewer  
Pipe Out @ 12 O'Clock

Deposits: ☐ None ☒ **Mud** ☐ Sludge ☒ **Debris** ☐ Grease

Silt Depth: **1** (in.) Deposits Extent: **Light**

Infiltration: **Evidence** Pipe Seal Cond: **Unknown**
